CONNECTICUT  
DEPARTMENT  
OF  
TRANSPORTATION

CONDITION INSPECTION  
FOR THE  
SPRINGDALE STATION

CONN. DEPT OF TRANSPORTATION  
STATION INSPECTION REPORT  
SHEET 2 OF 27

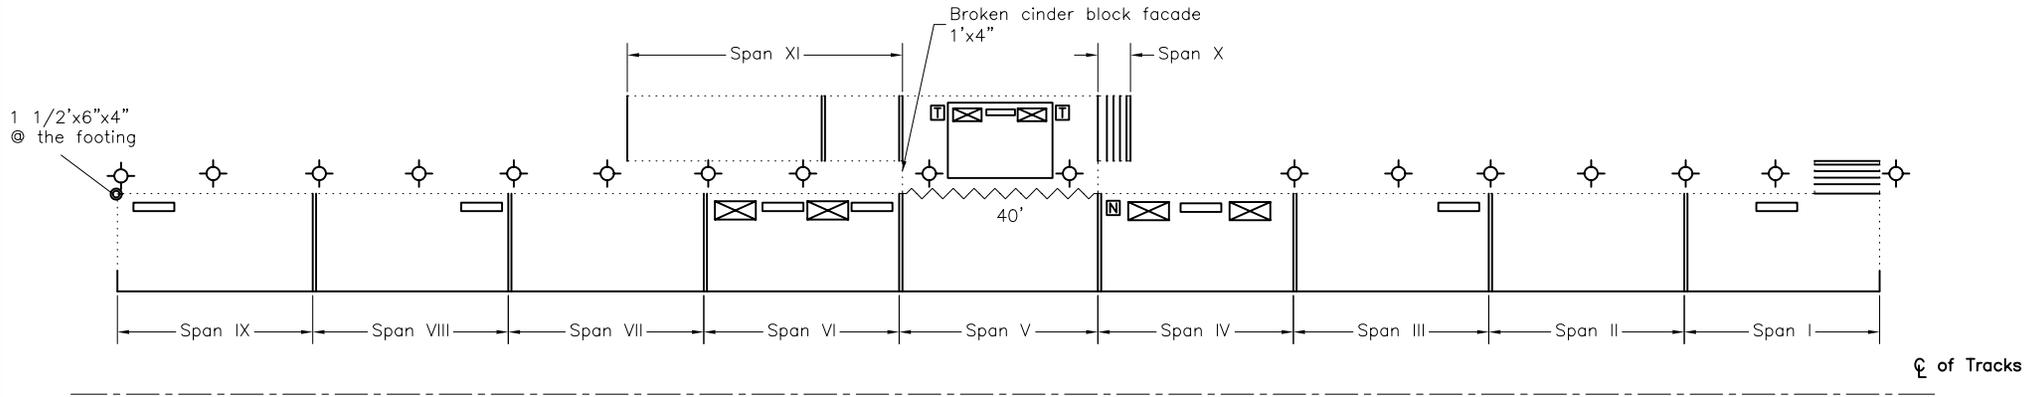
Urbitran Associates, Inc.
Connecticut Dept. of Transportation
Springdale Station Platform Plan
Date: 2-27-02

1. The base plates below the double tee are rusted and deteriorated.
2. Along the platform the railing is bent in multiple locations.
3. The railing base plates are rusted and deteriorated.

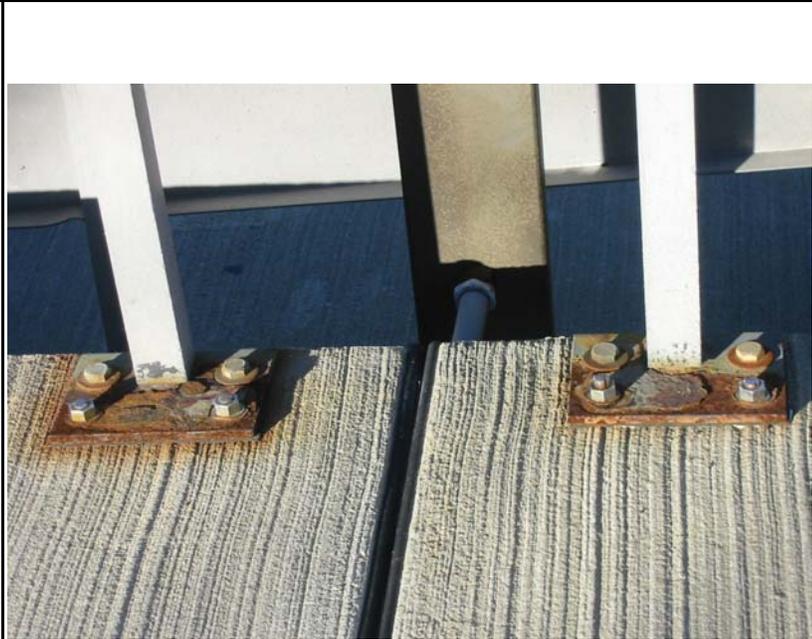
PHOTO NO. 9

Location: Between Span VI and VII

Description: The railing base plates are rusted and deteriorated

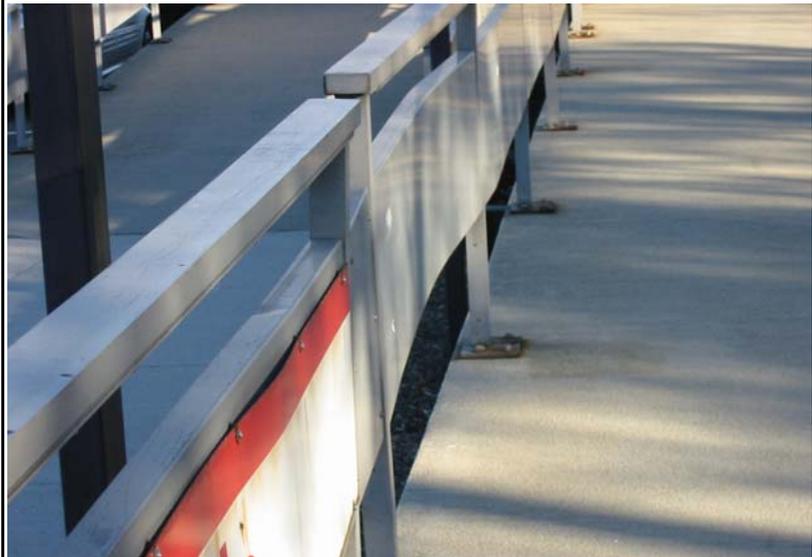
PHOTO NO. 10

Location: Span IV

Description: Typical bent railing

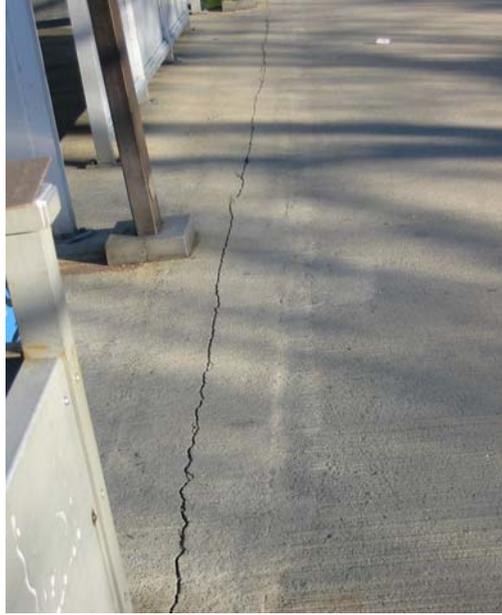
PHOTO NO. 11

Location: \_\_\_\_\_  
North end of Span V

Description: \_\_\_\_\_  
Crack (40')

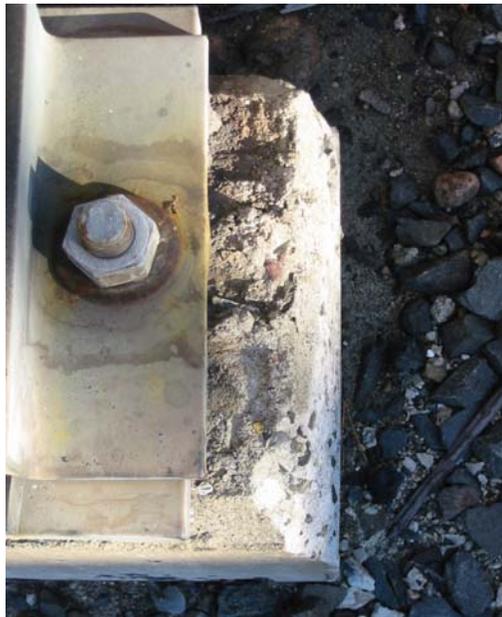
PHOTO NO. 12

Location: \_\_\_\_\_  
North of span IX

Description: \_\_\_\_\_  
Spalled concrete footing  
(1 1/2' x6" x4")

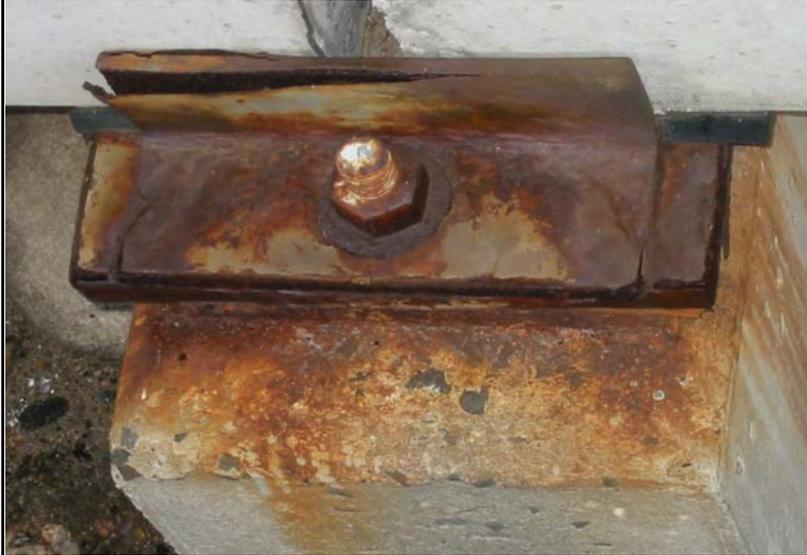
PHOTO NO. 13

Location: \_\_\_\_\_  
East of Span III

Description: \_\_\_\_\_  
Typical base plate  
that is rusted  
and deteriorated

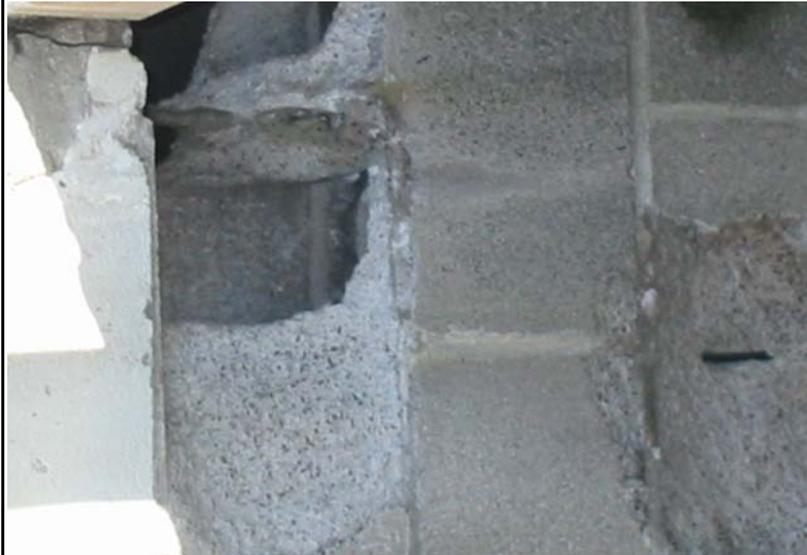
PHOTO NO. 14

Location: \_\_\_\_\_  
North of Span V

Description: \_\_\_\_\_  
Broken cinder block  
(1' x 4") on the north  
face of Span V;  
Note similar occurrence  
on the south face of  
Span V

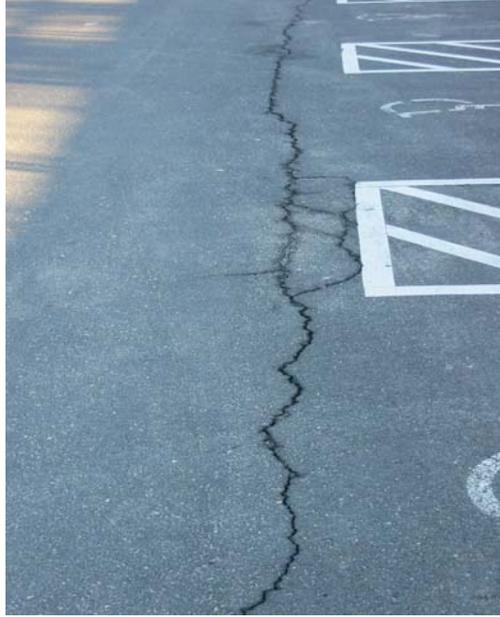
PHOTO NO. 15

Location: \_\_\_\_\_  
Middle of Quad II

Description: \_\_\_\_\_  
Typical asphalt crack

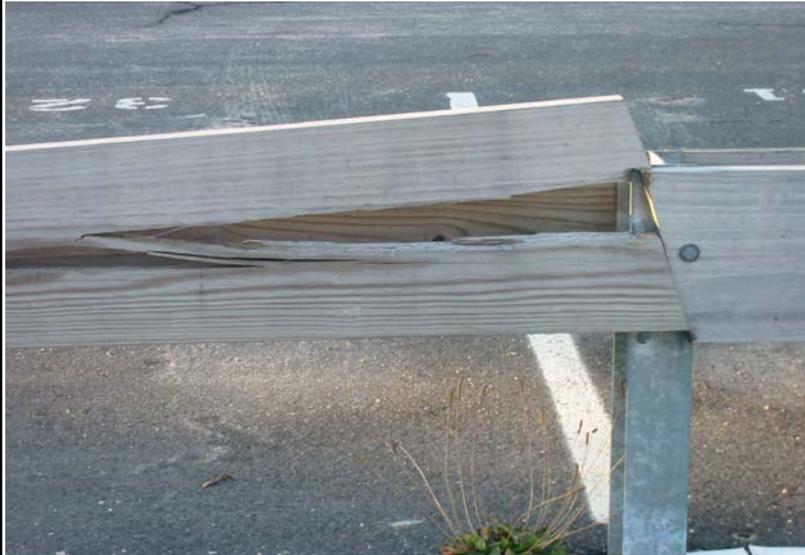
PHOTO NO. 16

Location: \_\_\_\_\_  
Middle of Quad I

Description: \_\_\_\_\_  
Splitting timber  
guardrail (5')

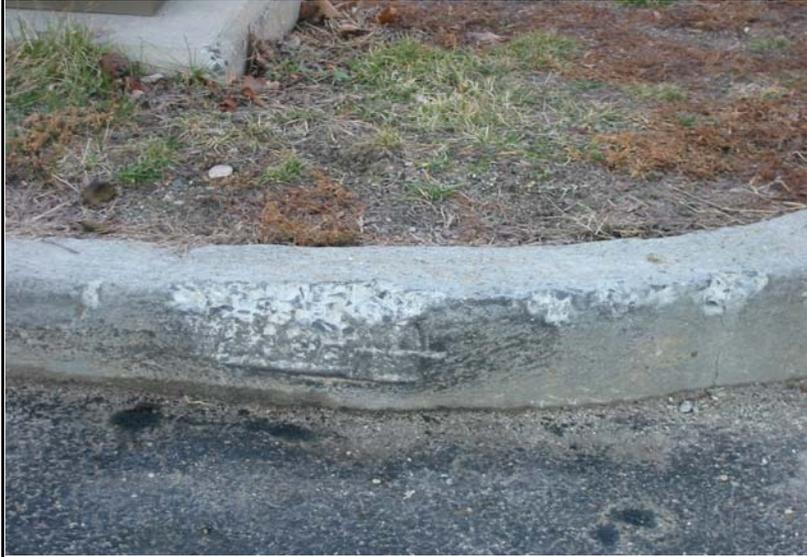
PHOTO NO. 17

Location: \_\_\_\_\_  
Northeast corner of  
Quad I

Description: \_\_\_\_\_  
Spalled concrete curb  
(4' x4"x2")

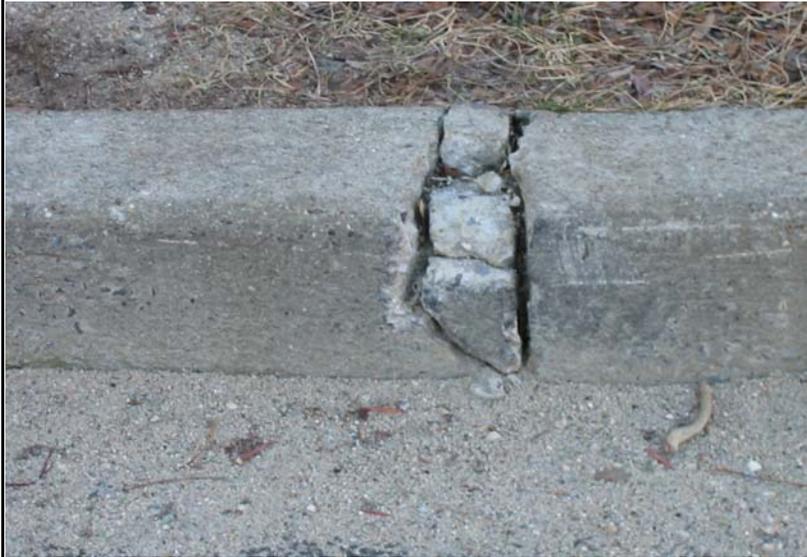
PHOTO NO. 18

Location: \_\_\_\_\_  
Northwest corner of  
Quad I

Description: \_\_\_\_\_  
Cracked concrete curb  
(6"x6"x2")

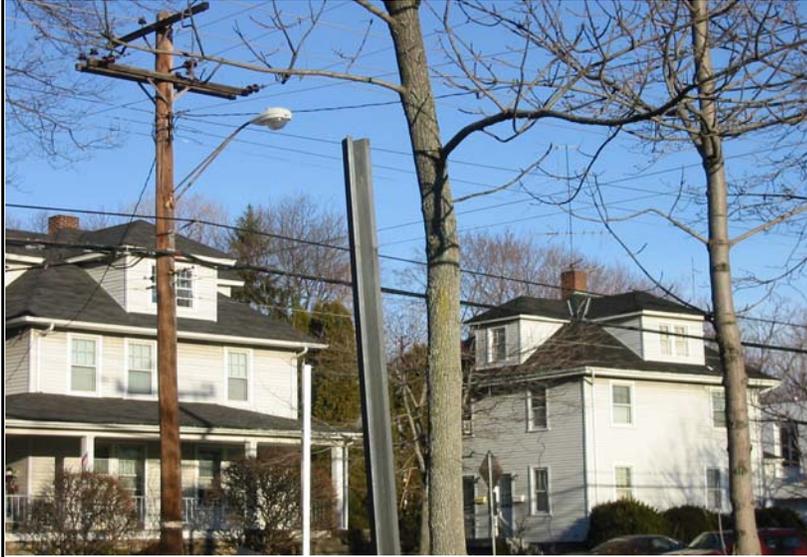
PHOTO NO. 19

Location: \_\_\_\_\_  
Northeast corner of  
Quad II

Description: \_\_\_\_\_  
The pole is missing a  
sign

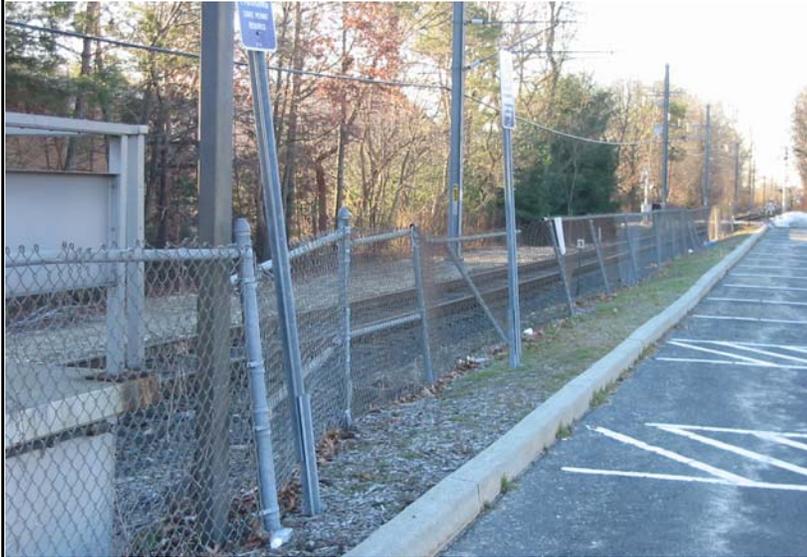
PHOTO NO. 20

Location: \_\_\_\_\_  
West side of Quad II

Description: \_\_\_\_\_  
Leaning, rusted, and  
damaged fence

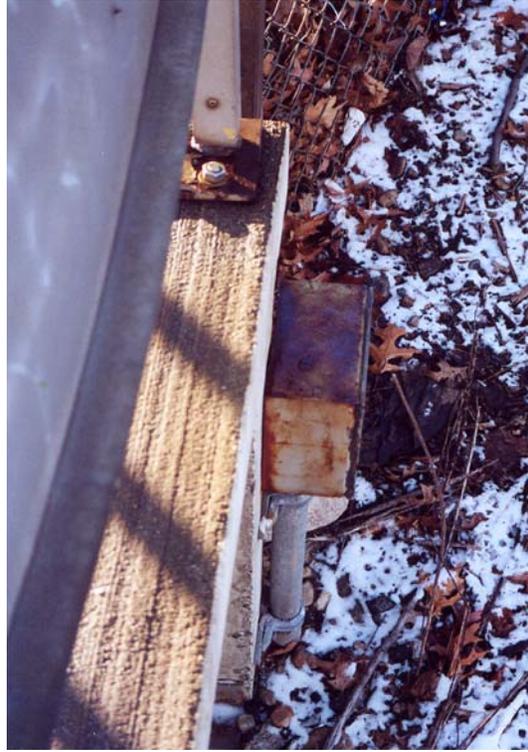
Remarks: We were unable to gain access to the electrical service enclosure to verify the size and condition of the main circuit breaker and panelboard.

The electrical service is underground and terminates in a locked pedestal type electrical cabinet located on the platform and inside a small shelter type structure. This cabinet houses the electrical meter and the main panelboard. We were unable to gain access to this cabinet to verify the exact size and condition of the main panel. However, the cabinet has only minor deterioration and appears to be protecting the electrical equipment from harm.

Description: \_\_\_\_\_  
underground  
electric service  
connection point

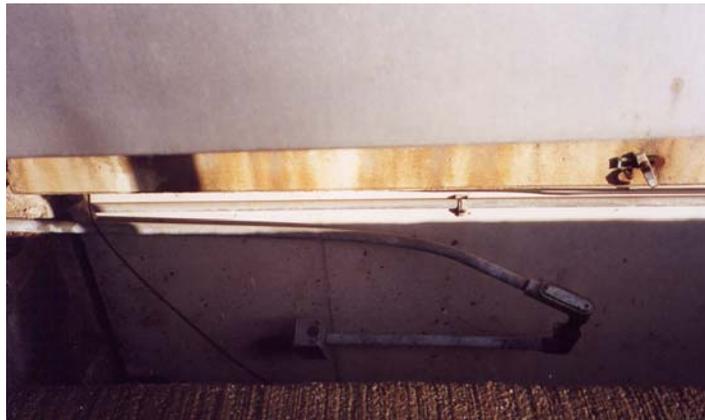
Remarks: We found one receptacle that was not properly mounted and should be repaired.

Description:  
a receptacle  
not properly  
mounted to the  
platform

There are several non-GFCI type receptacles located in the platform light poles that do not comply with the current NEC. We suggest that the receptacles be replaced with GFCI type to reduce the risk of electric shock when in use.

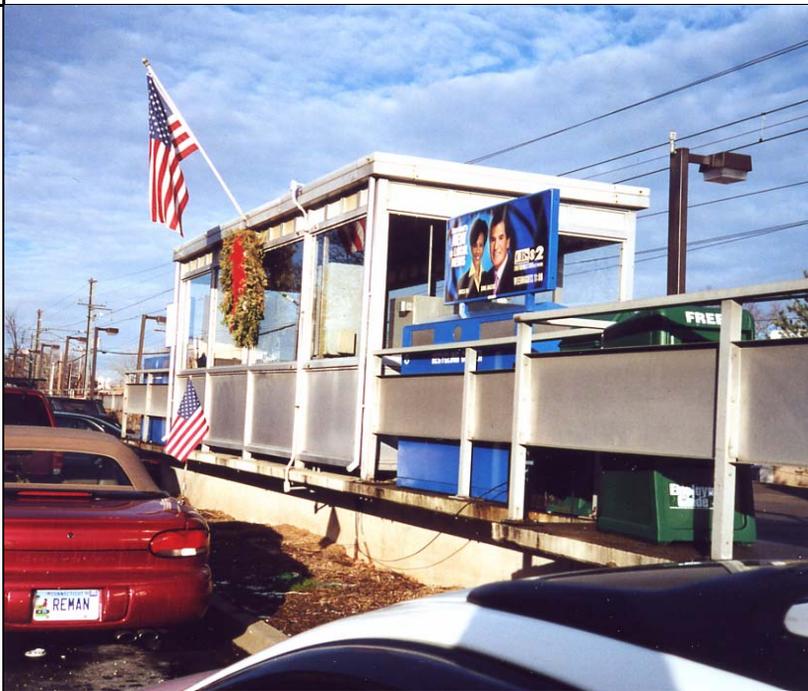
Description:  
Shelter on the  
platform w/ aluminum  
gutters and  
downspouts  
Good Condition
